NONPOINT SOURCE PROGRAM SUCCESS STORY

Pasture Grazing Best Management Practices Result in Pathogen (Fecal Coliform) Delisting

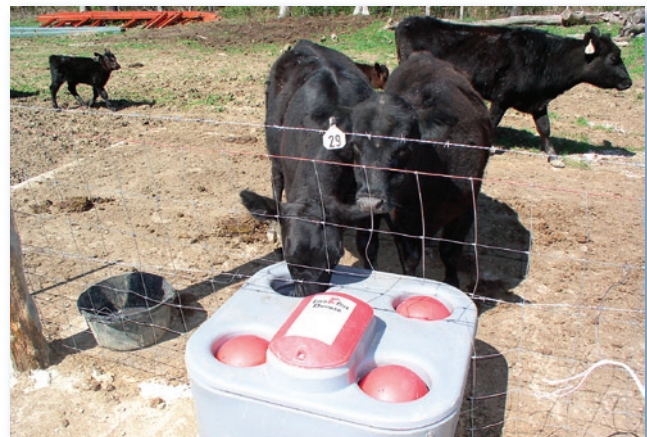
Exclusion fencing was installed to limit cattle's access to creeks, and alternative watering sources were constructed at eight different locations.

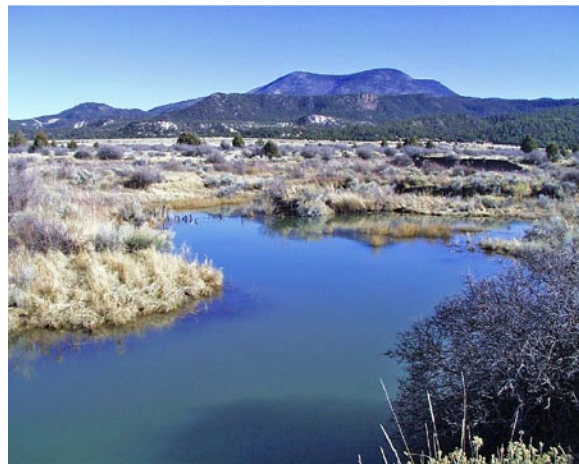
Newly restored Nutriosos Creek now has a higher water table, less erosion, and more wildlife species.

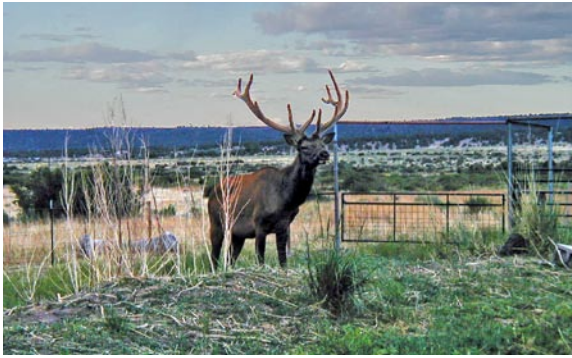
Crosswhite used fences to eliminate or control wildlife and livestock activities in the riparian areas.

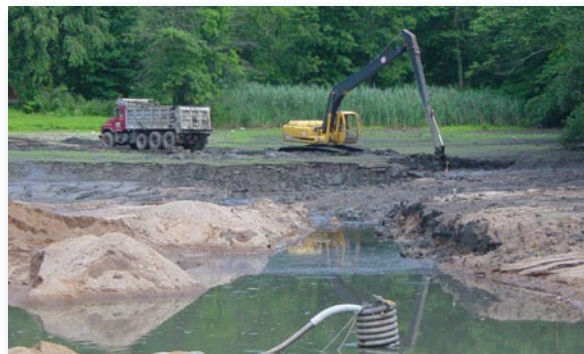
Decades of organic matter accumulation reduced average pond depth to 2.5 feet, with some areas as shallow as 1.5 feet. Dredging restored the pond to a maximum depth of 10 feet.

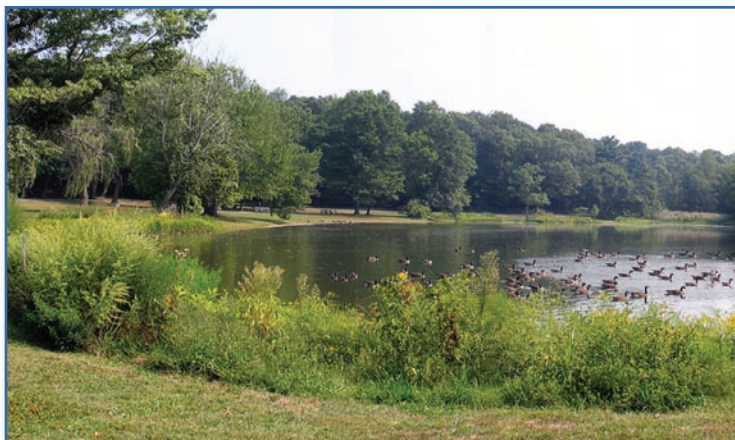
One view of Edgewood Park Pond after restoration. Littoral plantings and a stabilized bank are shown to the center and left.

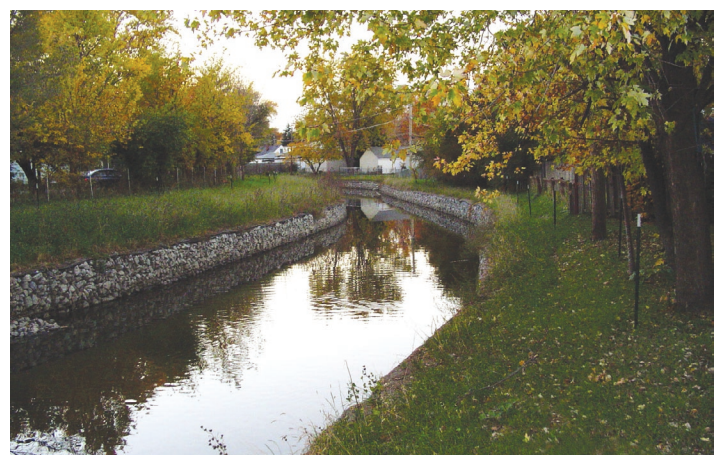
Figure 2. A gabion toe (cage filled with earth and rocks) protects the left and right banks in this section of Addison Creek.

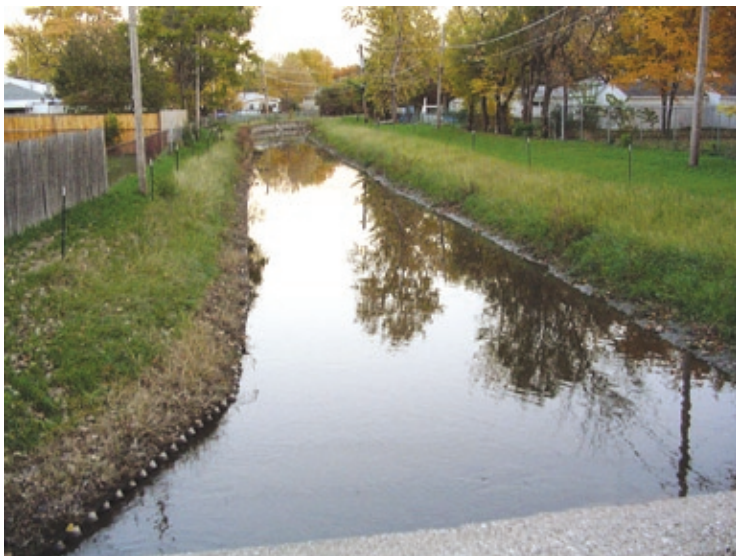
Figure 3. Streambank stabilization techniques used on this portion of the creek include vegetated banks with an A-Jacks toe on the left bank and a Stabulator toe on the right bank.

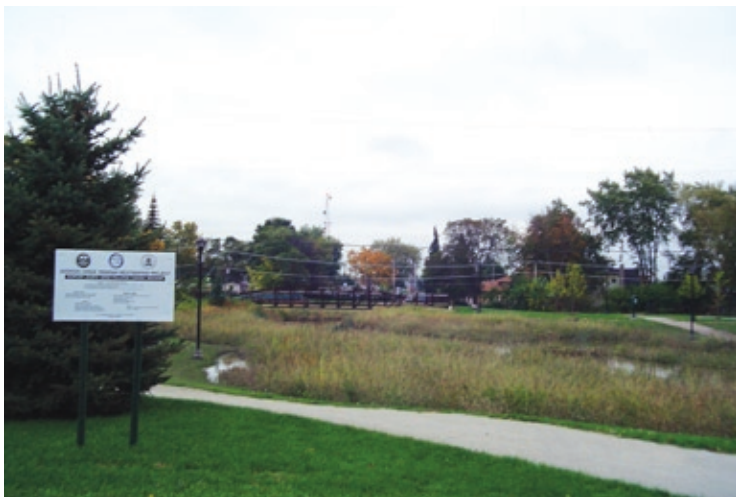
Figure 4. Along this section of the creek, the partners restored a streamside wetland and stabilized the streambank with vegetation, riprap, and riffles.

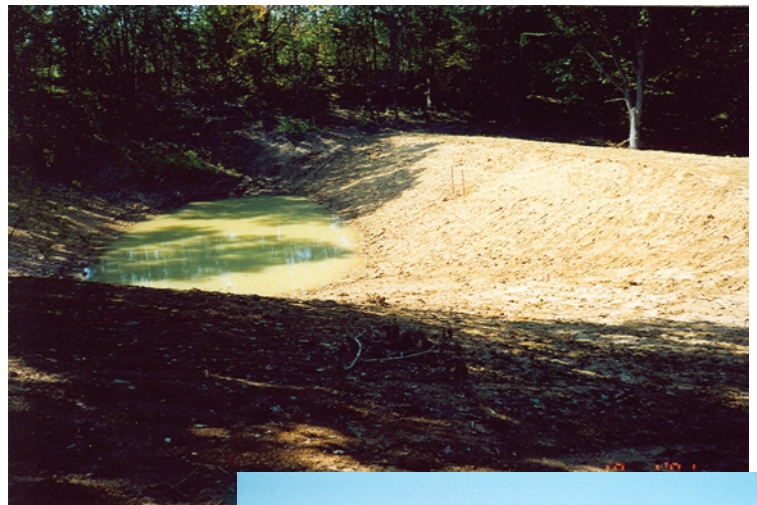
Sediment basins prevent excess sediment from reaching the lake by collecting runoff water and allowing sediment to settle out of the water and be deposited in the sediment basin.

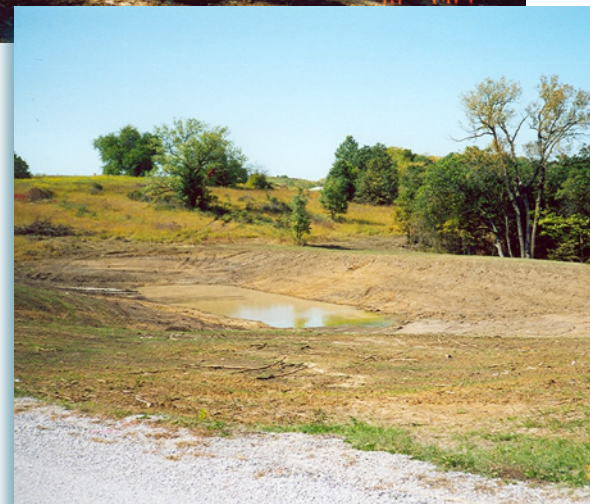
Sediment control structures were constructed throughout the watershed to reduce sediment delivery to the lake.

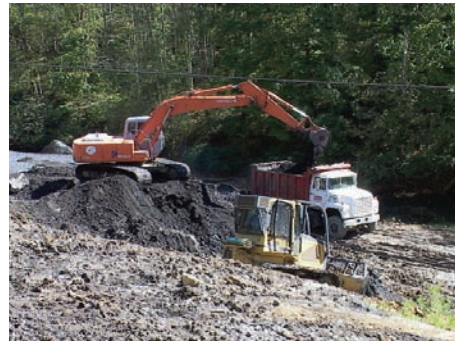
Bank restoration along Rock Creek has reduced sediment loading by 500 tons per year.

Fork of the Cumberland River from Rock Creek has decreased from a monthly average of 110 metric tons to near zero. Removing 25,000 cubic yards of coal refuse from streamside areas and revegetating the banks of Rock Creek have reduced the sediment entering the stream by 500 tons annually. Fish populations are improving in the lower Rock Creek watershed, and the number and diversity of fish species are increasing. Stations that once supported no fish are now supporting fish. Because of these improvements, Rock Creek has been reclassified from full nonsupport to partial support for aquatic life and swimming on the 2002 Kentucky 303(d) list.

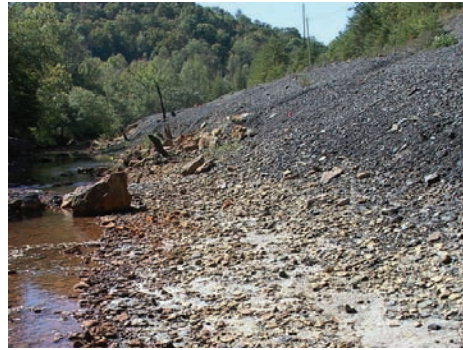
Rock Creek bank before restoration.

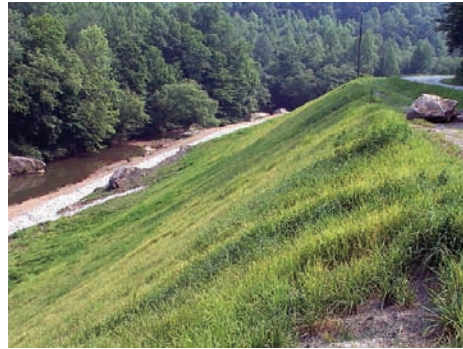
Rock Creek bank after restoration.

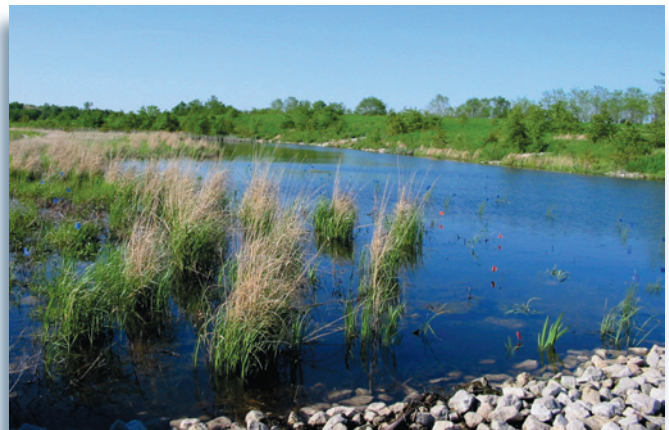
Acidity, sulfates, and metals are removed from AMD as it flows through layers of limestone rock and compost in the passive treatment wetland cells.

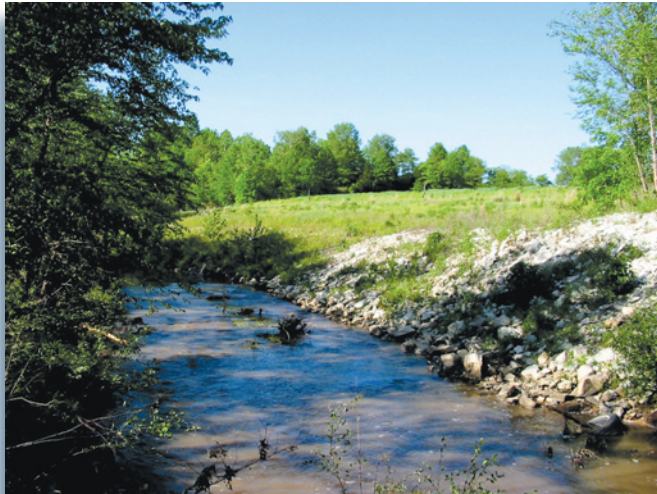
Native trees and grasses are thriving along sections of restored streambank.

neutralized. Streambank restoration projects further added to the health and renewal of the creek. Project partners planted approximately 200,000 native trees and shrubs and helped repair 2,700 linear feet of eroding streambank at 16 restoration sites. Sixty-six acres were amended and seeded with native grasses for erosion control and wildlife habitat enhancement. Additional native grass plantings are planned for the coming years.

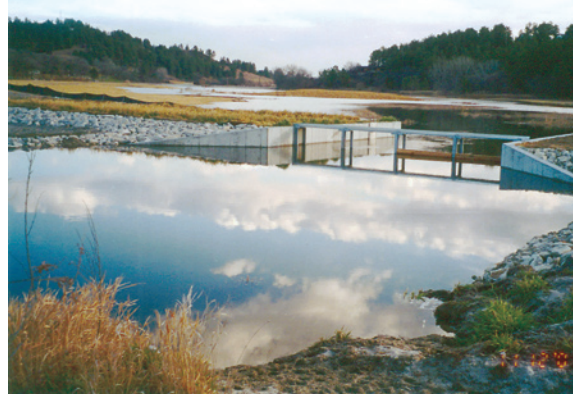
The hydro suction sediment removal system lies directly beneath the walkbridge shown here.

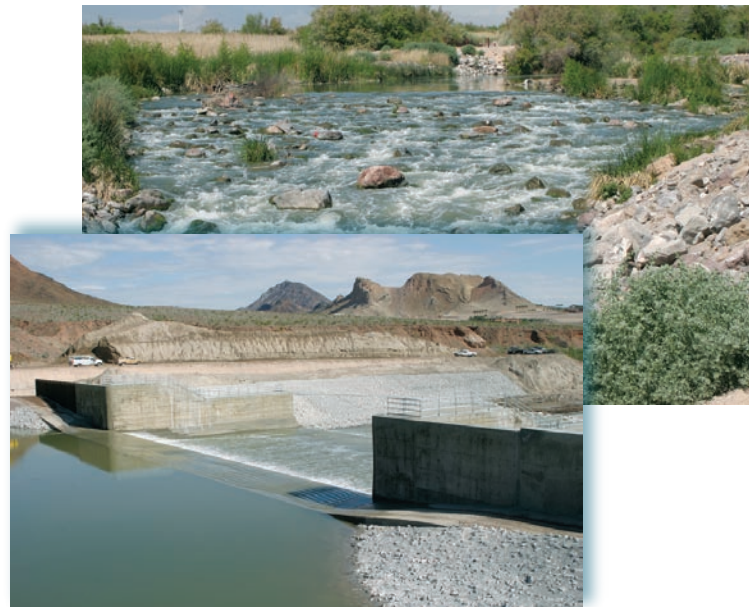
Weirs are low dams designed to reduce streambed erosion by flattening the slope of the channel and slowing flows. Many weirs are constructed of confined rock riprap, providing a somewhat natural look (top). Other structures are built with concrete, resulting in a more engineered look (bottom). Weirs, wetland restoration, and invasive vegetation removal helped reduce TSS concentrations in lower Las Vegas Wash and led to its removal from the Nevada 303(d) list in 2004.

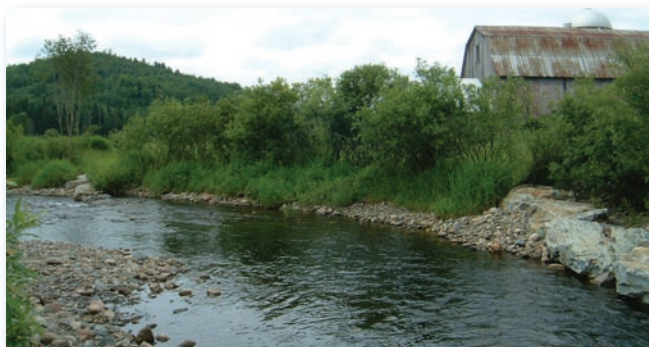
Bog Brook after restoration. The project saved the barn and stopped several thousand tons of sediment from smothering fish habitat.

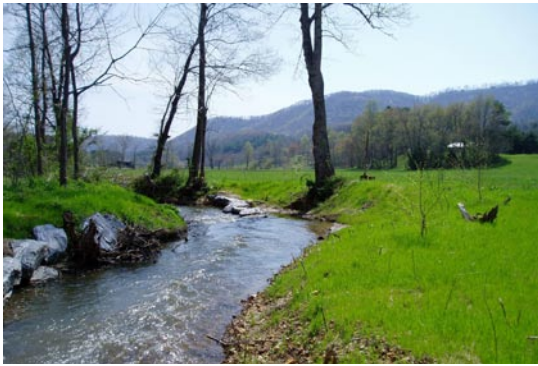
After: The rebuilt channel was designed with a more stable pattern, modeled after a similar, relatively undisturbed stream.

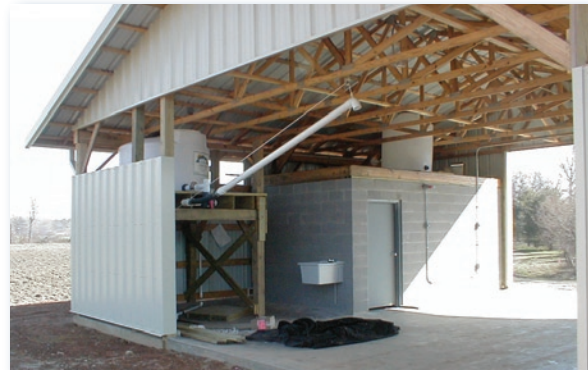
This chemical-handling facility replaced one that was directly adjacent to Mills River.

to the river segment. Project partners obtained three conservation easements totaling 192 acres, designated and planted 7.8 acres of riparian buffers, and restored nearly 4,700 linear feet of streambanks. In addition, they moved two chemical mixing stations away from river tributaries.

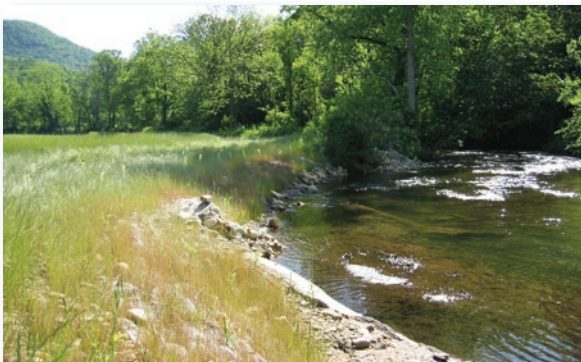
Streambank and buffer restoration shortly after tree planting. Small trees are in the tall grass on the left.

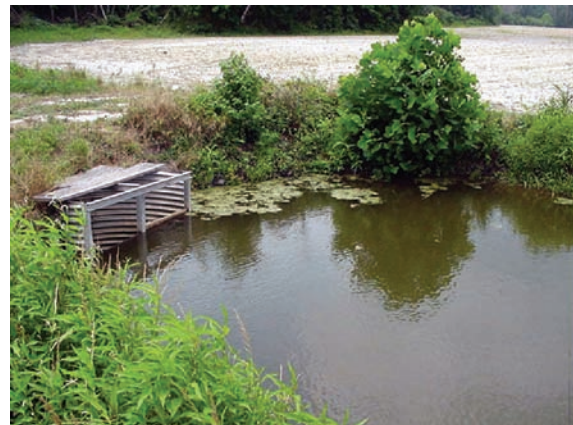
Area farmers installed water table control structures like the one shown here to address excess nutrients.

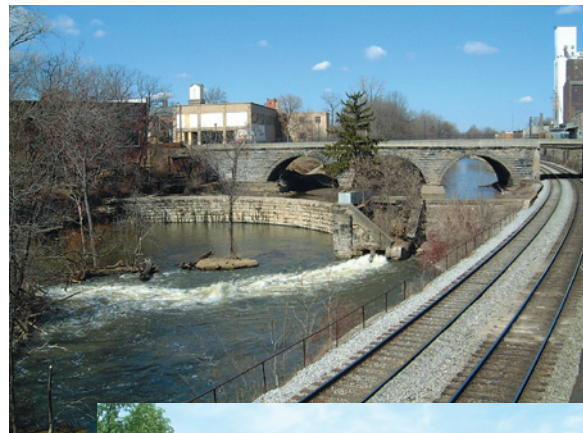
The dam pool was eliminated by removing an old canal lock and allowing the river to return to free-flowing conditions.

Ohio EPA determined that the Kent Dam was contributing to water quality problems due to stagnant flows and eutrophication within the dam pool, causing dissolved oxygen levels to fall well below water quality criteria during periods of low flow. The dam pool altered aquatic habitat, impairing both the health and diversity of indigenous fish species. Additionally, the dam posed a physical barrier to fish migration.

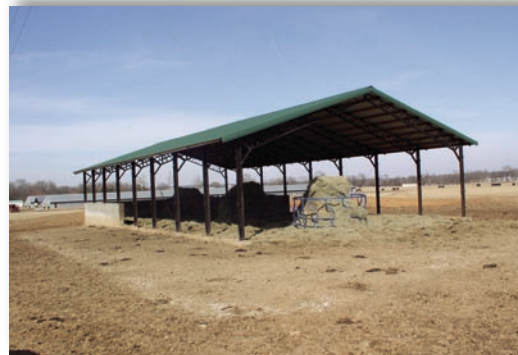
Areas for cattle feeding and waste storage were constructed to reduce the amount of bacteria and nutrients entering the stream.

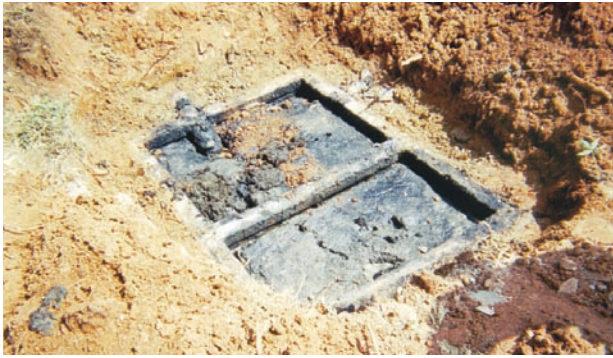
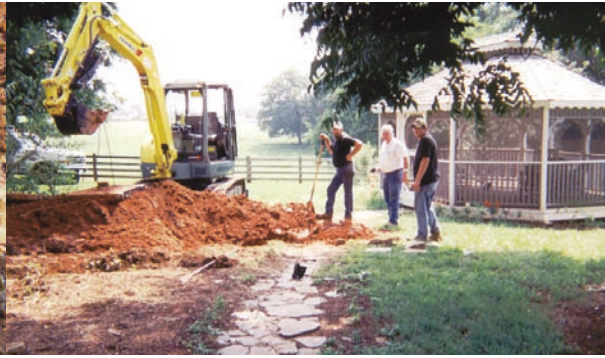
This septic tank was completely filled with solids. Cooperators removed the solids and replaced the tank.

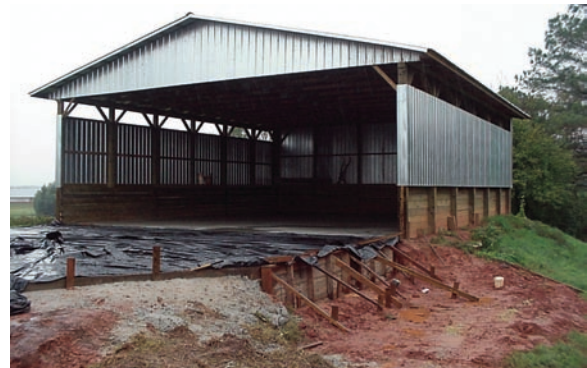
Waste stacking sheds, like this one, reduce the amount of fecal coliform that washes away after a rain event.

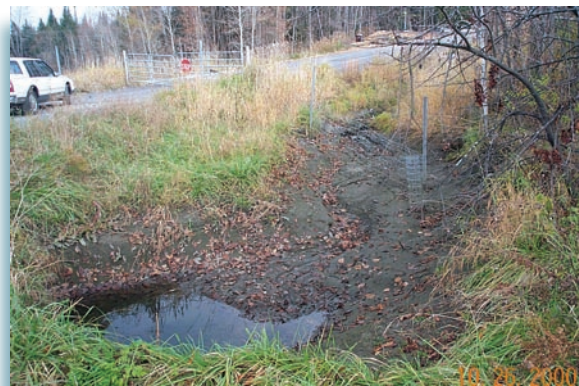
Ditch near Adams Brook prior to being lined with rock. Rock lining reduced sedimentation into Adams Brook.

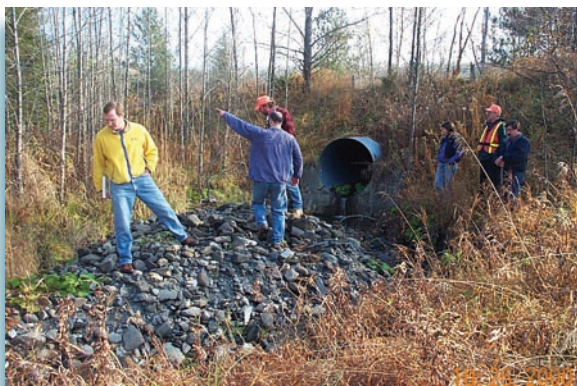
Geomorphic instability and an unauthorized culvert (upstream of the location in this photo) caused heavy erosion and the dumping of rock piles at the culvert shown here. Removing the unauthorized culvert helped to address the instability and reduce the water quality impacts on Adams Brook.

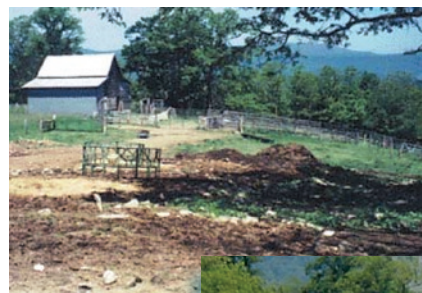
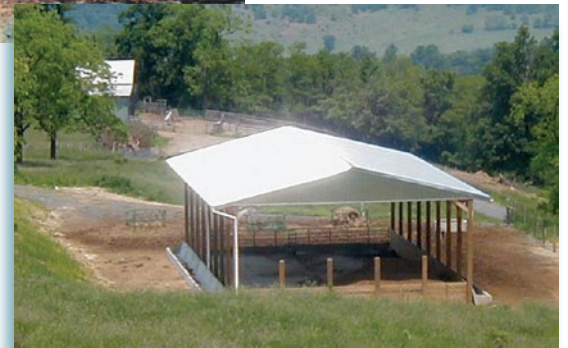
Before

An animal feedlot that allowed runoff of contaminants into the nearby stream.

After
A new animal feedlot that is covered and has a concrete pad and adequate buffer has been installed.

Since then, a range of BMPs have been established to help control runoff from feedlots and eliminate or reduce cattle access to the streams. To keep cattle out of the streams, farmers installed streambank fencing and developed alternative livestock watering facilities. Farmers also constructed roofs over feeding areas, as well as new animal waste storage facilities to provide shelter and prevent runoff. Other efforts focused on streambank restoration through stabilizing critically eroding areas and

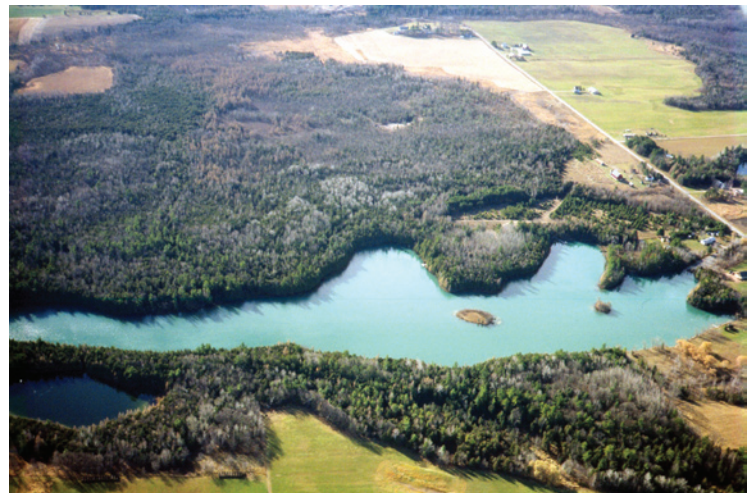
Bass Lake just after alum treatment, which helped reduce phosphorus in the lake.

basins and restoration of wetland areas to prevent further loading. The remaining livestock operation further reduced runoff from livestock areas by moving animals into a free stall facility where cows are kept indoors in large pens. A sediment control basin and a leachate collection system—designed to collect polluted runoff and pump it into the manure storage—were also installed on the farm to virtually eliminate pollution transport from livestock areas to Bass Lake. With support from the Wisconsin Department of Natural Resources (DNR), LWCD worked with a professional consultant to treat Bass Lake with alum during fall 1999 to break the cycle

of internal phosphorus release from sediment on the lake bottom and to reduce phosphorus levels in the lake.
